## ADSL Synchronisation problems

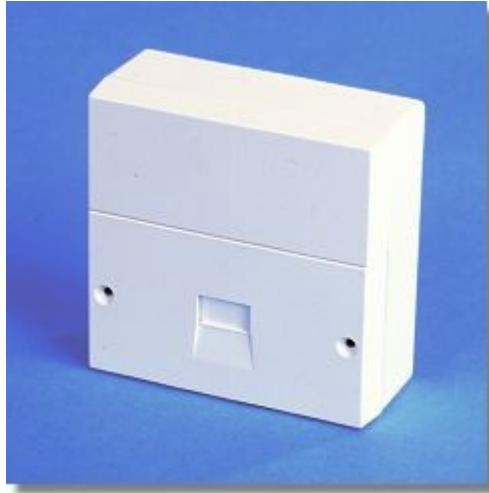
The image above shows a standard BT master socket. You will normally have just one of these on your telephone line usually near to where the telephone cable enters your premises.

You can identify the master socket by the split front plate. Inside the master socket is an engineers test socket - this is located underneath the bottom half of the face plate, to the right. The two screws on the bottom half will need to be removed in order to remove the lower half of the faceplate. The faceplate simply pulls out, once unscrewed.

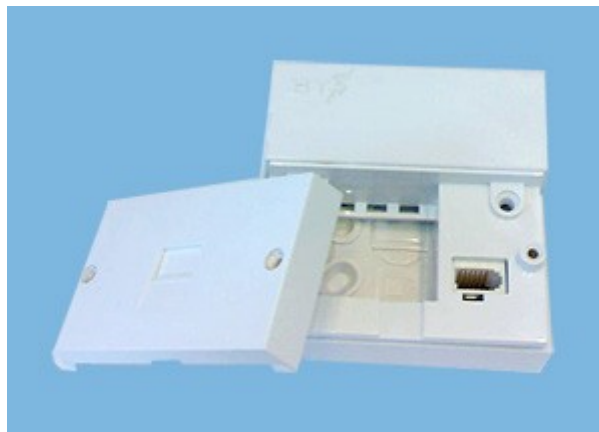
This shows the master socket with the faceplate removed. The socket on the right is the engineers test socket.

To test your master socket you will need to connect your ADSL equipment into the test socket. Use only the short cable supplied with your ADSL modem. Do Not use long extension leads as these can themselves be the source of the problem.
